## Detrainment South of Crystal Palace Station

2<sup>nd</sup> March 2018

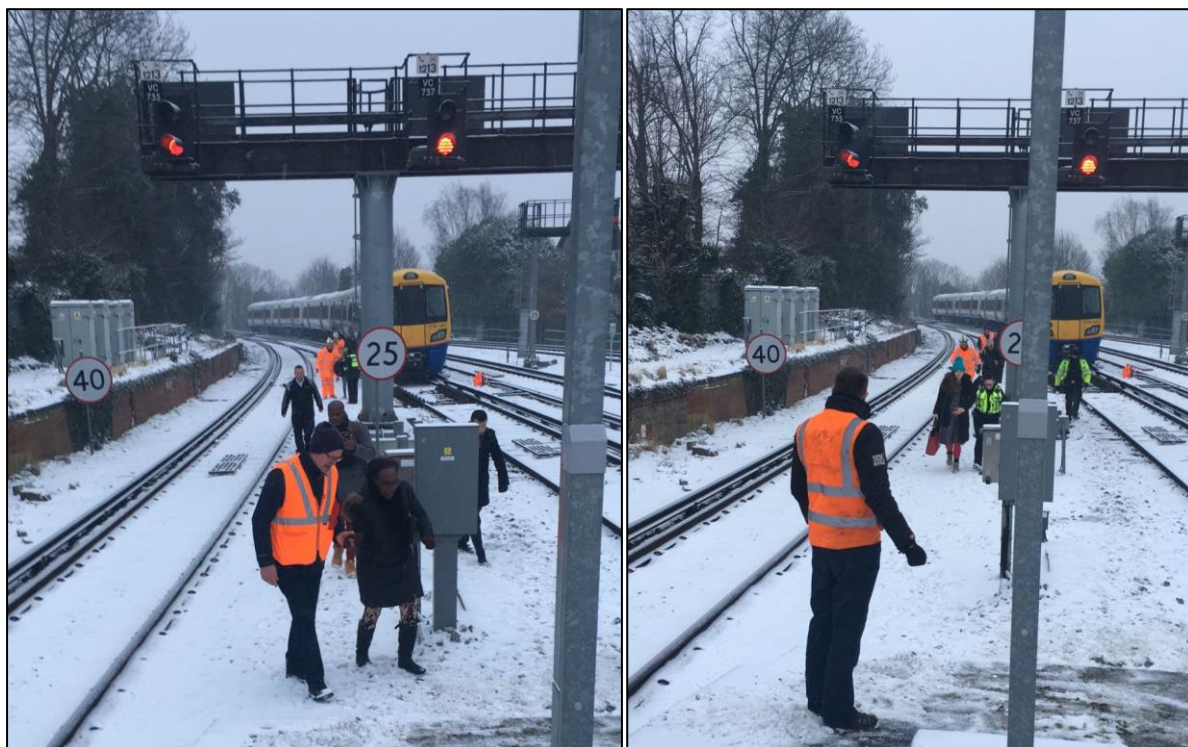
At approximately 15:20, a London Overground service approaching Crystal Palace station failed when trying to climb the incline into the station. The train had been proceeding slowly towards Crystal Palace for some time and finally came to a halt approximately 30 metres from the station.

It became clear by 16:55 that the rescue loco would not be able to couple to the failed train. A decision was then taken to implement a controlled evacuation. The walking route to the platform was cleared of snow and, following the discharge of the electrical current, detrainment began at 17:15, with the last customers arriving at the station by 17:40.
