Secretariat memorandum

Agenda item 7

TA 19

Bus staircase design

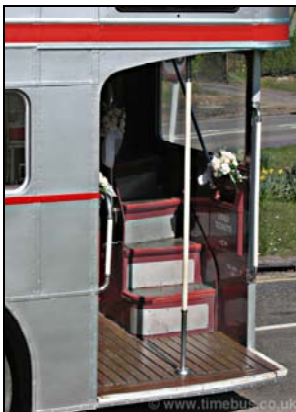
Fig 1 : Routemaster staircase

2.2.1 The traditional London (and British) double deck bus design was established in the 1920s. It had the engine alongside the driver at the front, and an open platform entrance/exit at the back. The staircase was in the rear offside corner, turning through 90° (Fig 1). It included a curved section where the stair treads were narrower on the inside than on the outside, but the overall design of the staircase – at least in its final incarnation on the Routemaster – was such that this feature did not seem to cause much difficulty to most passengers who were capable of climbing this steep narrow staircase at all.

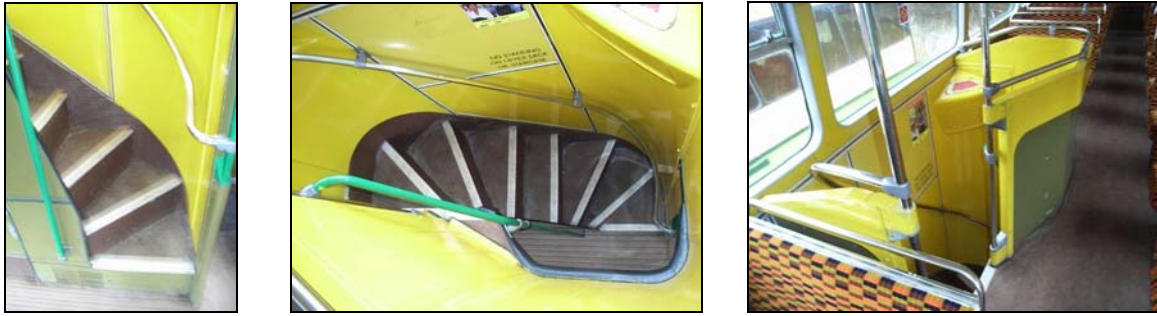
Fig 3 : Titan staircase

2.2.3 The 1980s saw London standardise on two double-deck bus designs – the Titan and the Metrobus. The Titan (fig. 3) was very similar to the DMS, although the spiral effect was (if anything) worse towards the bottom of the staircase.

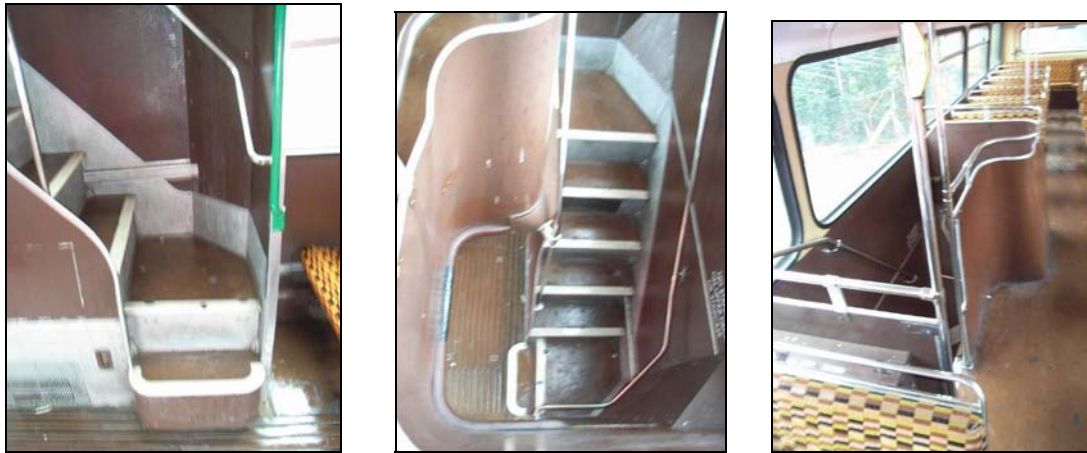
Fig 4 : Metrobus staircase

The Metrobus, however, was different (Fig. 4). The spiral effect was eliminated by squaring off the turns. The price for doing this was that the bottom step protruded into the gangway area of the lower saloon, reducing the width of the route from the entrance at the front to the seats at the back. In practice this was not a problem, because there were no seats opposite the staircase as this was deliberately aligned with the exit doors.

Of the various designs to date, it appears that the square staircase as used on the London Metrobus of the 1980s offers the best solution. It is easy to climb, and the

absence of both the long open drop and the narrowed treads at the inner side of a spiral makes it the least difficult to descend.

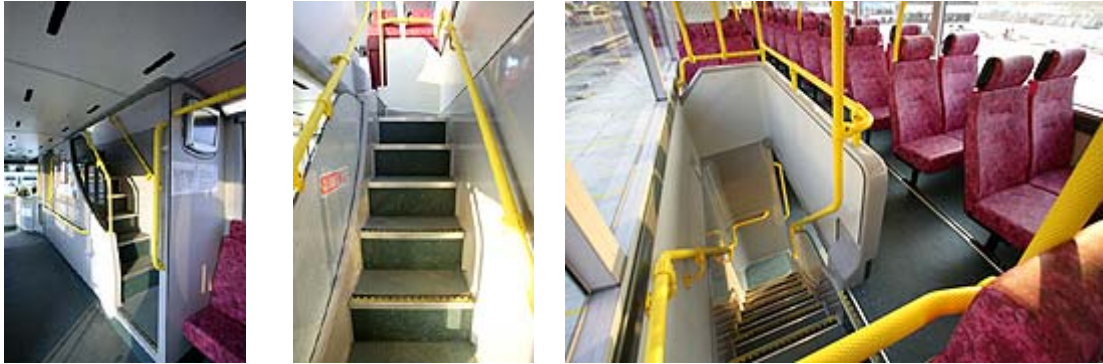
Fig 5 : Straight staircase

Early designs offered many different detailed arrangements for staircase, wheelchair and exit door positions and (prompted by London Buses) some had a new design of staircase – the straight staircase (although this was not actually new, as it had been tried in London in the 1930s and soon abandoned) (Fig 5).

There was little doubt that for people who use the upper deck of a bus (i.e. those with no serious mobility impairment) a straight staircase was easy to climb and – when demonstrated on a stationary vehicle – easy to descend. However they have not been universally adopted, as many non-London operators still specify the spiral design; one reason for this is probably that the spiral occupies less space and therefore allows more seats.

2.2.5 For the passenger, the problem with a straight staircase becomes apparent once the bus actually moves. The reality is that a bus lurches about – back and fore, sideways, up and down and in any combination of these – and can brake suddenly. For passengers going up the stairs there is no real problem; if they are thrown off balance the worst that is likely to happen is that they fall forward onto the staircase. This is unpleasant and may result in minor injury, but it is a risk which passengers seem willing to take.

Descending a straight staircase is different. When standing at the top, the passenger looks down on a long open space which offers an unbroken fall if the bus lurches or brakes suddenly. Even for the most able bodied, this is psychologically disturbing, causes most users to hesitate as they descend (thus slowing the unloading of the bus) and is particularly difficult for those who are carrying bags and therefore have only one hand free to hold the handrail.
